APPLICATION NOTE 3479

DS2154 – Migrating from Revision A2 to D1

Abstract: This application note describes the procedures for replacing the A2 revision of the DS2154 with the D1 revision of the DS2154. The D1 revision of the DS2154 is a drop-in replacement for the A2 revision of the DS2154. However, it is possible that the user may experience a timing-related issue while replacing the parts. This application note will describe what to do to correct this problem.

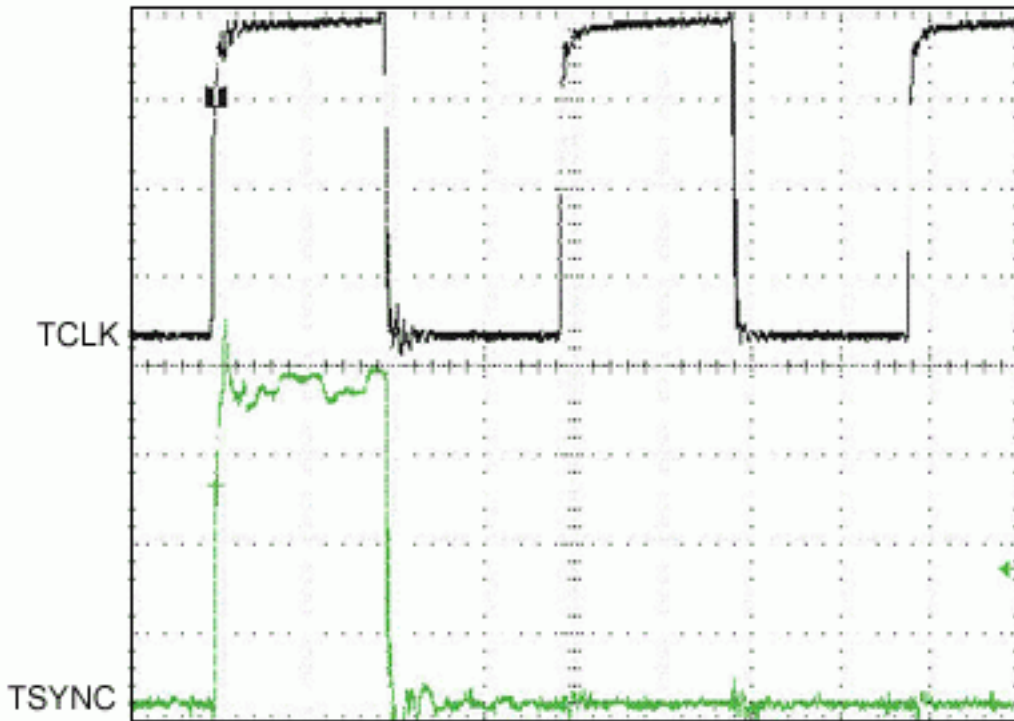
Figure 4. Transmit-side timing between TSYNC and TCLK taken from an oscilloscope.

In the DS2154 D1 revision, when TSYNC is configured as an input by setting TCR1.0 = 0 (TSIO = 0), the E1 SYNC signal sometimes does not synchronize correctly with the MSB of time slot 0 (TS0). **Figure 4** is the scope image of a possible valid timing diagram between TSYNC and TCLK for the DS2154 A2 revision. However, this is not valid for the DS2154 D1 revision.

Figure 4 shows the falling edge of TCLK and TSYNC as being nearly simultaneous. In the D1 revision, the incoming TSYNC is sampled at the falling edge of TCLK. In order to get the correct sampling, the user needs to add 25ns or more delay onto TSYNC. The user can also make the clock pulse of TSYNC wider. This way, the user can solve the sampling problem. The A2 revision of the DS2154 has a rising edge detector to aid in aligning TSYNC with TS0. The D1 revision of the DS2154 simply samples TSYNC with the falling edge of TCLK. **Figure 5** shows the timing diagram between TCLK and TSYNC after making the TSYNC pulse wider.

When replacing the A2 revision of the DS2154 with the D1 revision, most applications will never experience this timing issue. However, if the application experiences this problem, it is recommended to increase the TSYNC delay by 25ns or to widen the TSYNC pulse. For further questions about the operation of the DS2154, please contact the Maxim Telecommunications Applications support team through email: telecom.support@maxim-ic.com, or phone: 972-371-6555.
